TRANSPORTATION RESEARCH CENTER

ON-SITE AIR BAG INVESTIGATION

CASE NO. - 96-18
FLEET - PRIVATE VEHICLE
LOCATION - CASE ACCIDENT DATE - 1996

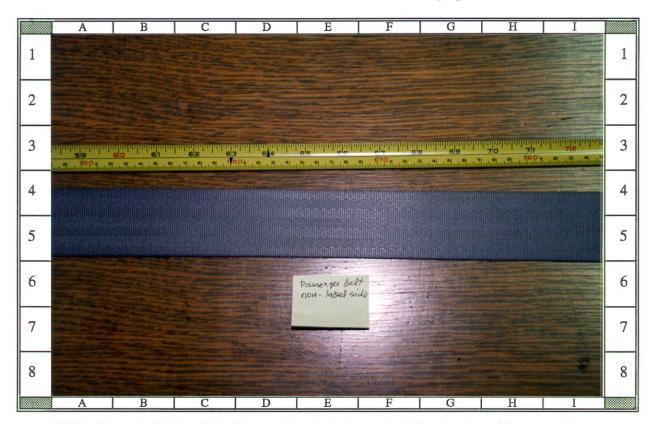
#119: Case Vehicle's right front safety belt (i.e., 6 of 7) showing side away from a restrained passenger; NOTE: no evidence of loading

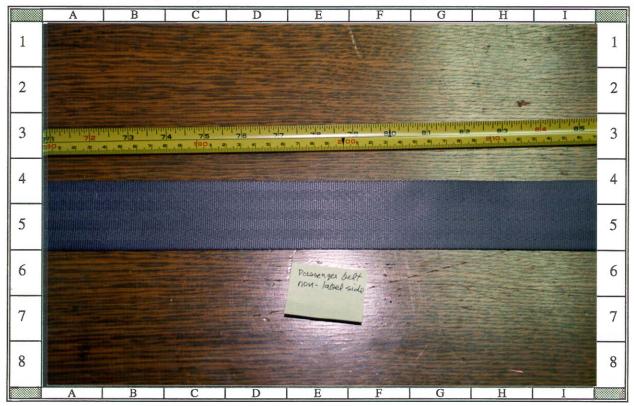
#120: Case Vehicle's right front safety belt (i.e., 7 of 7) showing side away from a restrained passenger; NOTE: no evidence of loading

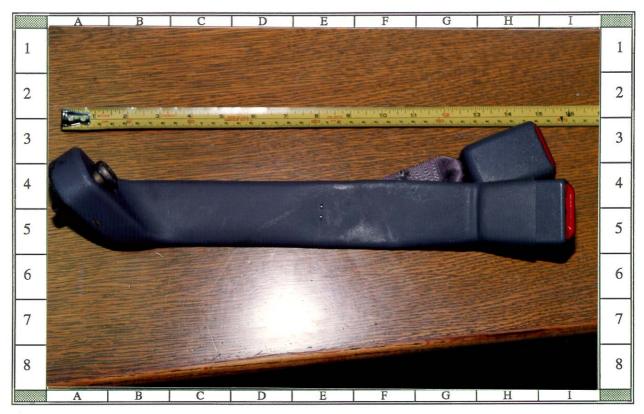
#121: Case Vehicle's floor mounted buckles for center and right front safety belts showing evidence of interaction with right front seat

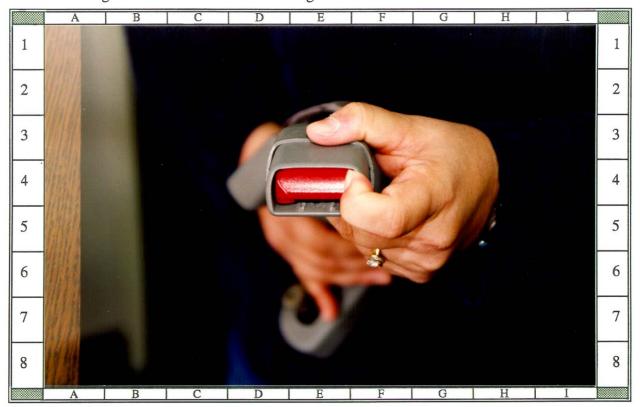
#122: Close-up of Case Vehicle's floor mounted buckle for right front safety belt showing evidence of normal usage but no evidence of loading on mechanism

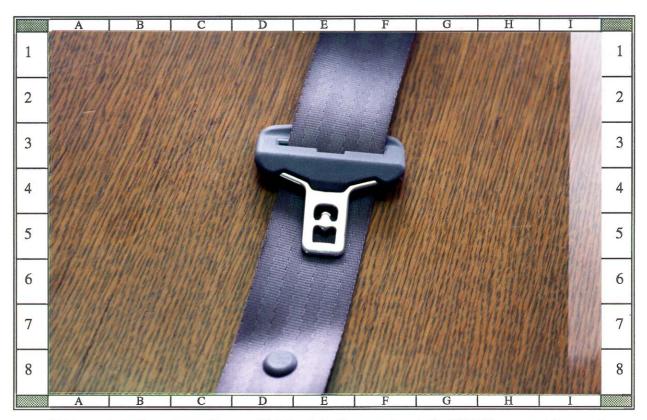
#123: Latch plate from Case Vehicle's right front safety belt; NOTE: no evidence of loading on latch plate

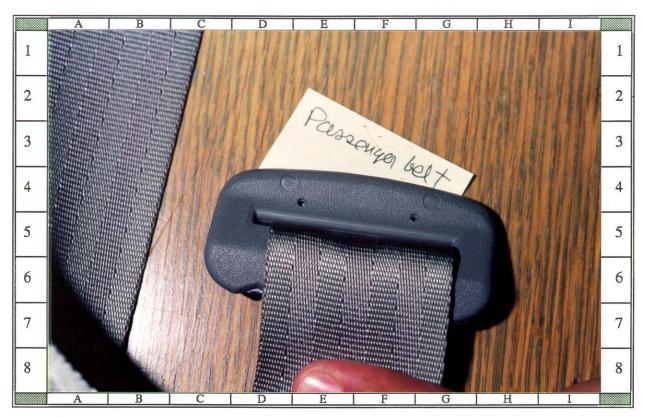
#125: Latch plate adjuster from Case Vehicle's right front safety belt showing adjuster's side that would be away a restrained passenger; NOTE: no evidence of loading
